# Cliff collapse at Stevns Klint, south-east Denmark

Stig A. Schack Pedersen and Tove Damholt

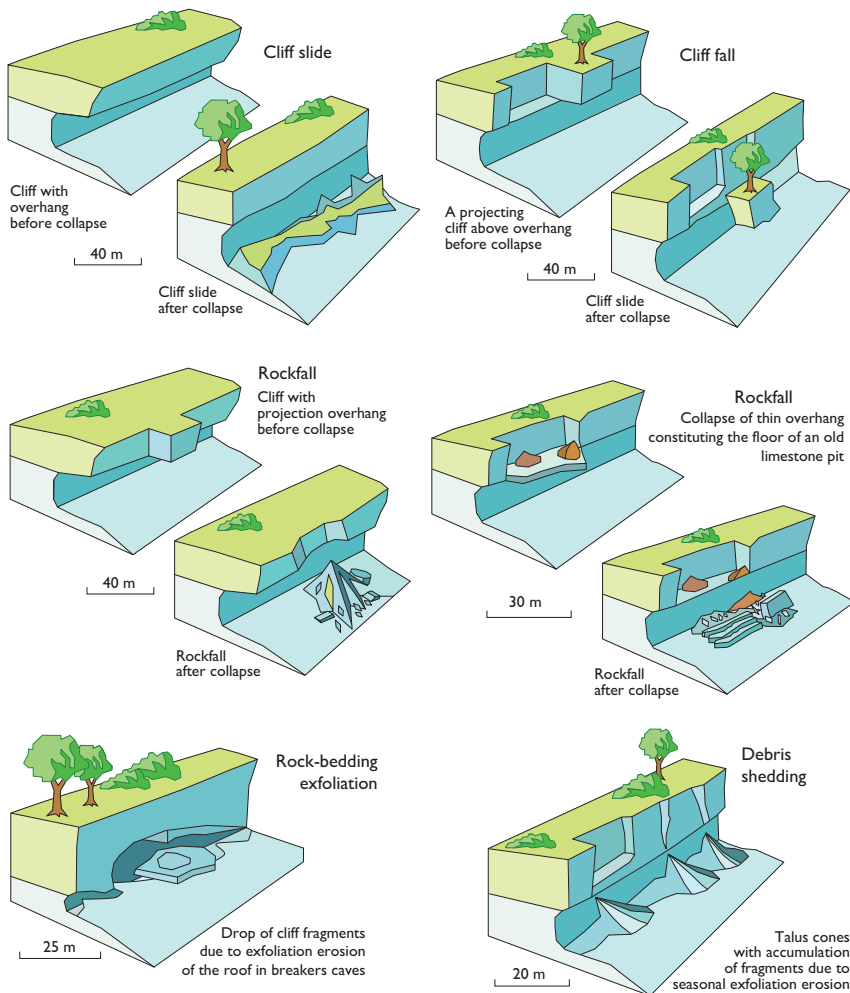
The largest type of cliff collapse at Stevns Klint can be called cliff slides (Fig. 3). This type of slide includes a major part of the cliff for several tens of metres along the coastline which slide simultaneously. In general a cliff slide takes place along a steeply dipping surface and it involves a volume of 5000 to 10 000 m<sup>3</sup>. Prior to a cliff-slide a whole section of the chalk has been eroded away at sea level, creating an undercut below the limestone and resulting in a considerable overhang. The size of the overhang has to be around 10–12 m and the thickness of the limestone and till in the overhang around 15–18 m before it becomes unstable.

Fig. 3. Cliff-collapse types at Stevns Klint. The most hazardous type is the cliff slide involving volumes of 5000–10 000 m<sup>3</sup>. The volume of a cliff fall amounts only to 500–1500 m<sup>3</sup>, but still a cliff fall is an impressive sight with the bedding completely preserved in a displaced cliff fragment. The rockfall is the general type of cliff collapse and is illustrated by two examples, of which the plate-like overhang corresponds to a recent cliff collapse at Knøsen. The rock-bedding exfoliation generates platy 1–10 m<sup>3</sup> limestone blocks, which drop from the underside of the overhang. The main erosion of the cliff is caused by debris shedding, which produces the talus at the foot of the cliff.

In order of decreasing size, the next type of large collapse is the cliff fall (Fig. 3). Cliff falls only involve isolated projecting parts of the cliff with a considerable overhang and their volumes are 500–1500 m<sup>3</sup>. The cliff fall is a simple drop of part of the cliff where the bedding of the fallen block is preserved after the fall. The average relation between thickness and depth of the overhanging limestone prior to cliff fall is 3 to 2 as illustrated in the cliff fall below the lighthouse of Stevns Fyr (Figs 1, 5B).

The third type of collapse is classified as rockfalls (Fig. 3), which in this analysis varies in size from 1 to 500 m<sup>3</sup>. This type may occur together with block slides, in which bigger blocks are displaced together with finer-grained material such as clayey till and sand. The resulting aggradation of material on the shore after a rockfall is a chaotic breccia. In general, rockfalls leave a concave escarpment in the cliff and the aggradation of debris results in a cone expanding out into the sea.

Platy rockfall, caused by rock-bedding exfoliation, involves rock volumes of around 1 m<sup>3</sup> and is a significant type of collapse at Stevns Klint (Fig. 3). Rock-bedding exfoliation occurs in caves eroded by storm waves in the lower part of the cliff. Layers are peeled off from the roofs of the cave due to exfoliation, and dish-shaped fragments of rock drop to the cave floor. Caves are prominent north of Boesdal (Fig. 1) and

Finally, fragments of rock may fall from the cliff due to general shedding of debris (Fig. 3). In general, the material resulting from debris shedding is pebbles and cobbles, whereas clasts of boulder-size are loosened only occasionally from the cliff surface. The result is seen as an apron of talus along the foot of the cliff, typically with irregular conical shapes. Debris shedding results from contraction and expansion due to seasonal variation of frost and thaw in winter time and desiccation during the summer. The rate of erosion due to debris shedding is equal to the average rate of erosion, i.e. 15 cm/year.

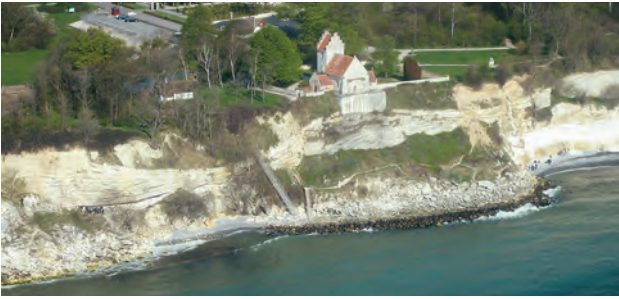
Fig. 4. Aerial photograph of the cliff section at Højerup gamle Kirke (medieval church).

Højerup gamle Kirke (a medieval church) that rested on a 15 m thick overhang. The slide continued several tens of metres out into the sea (Fig. 4). Shortly after the incident the cliff was protected by wave breakers to inhibit wave erosion and to secure the rest of the old church. Prior to the spectacular slide, the undercutting erosion had lasted for 160 years following an earlier slide in 1767 (Rasmussen 1967). Before the cliff collapse in 1928, the overhang amounted to *c.* 12 m measured perpendicularly to the orientation of the cliff and a similar overhang size is estimated for the collapse in 1767. An overhang of *c.* 12 m is thus regarded as a critical size for cliff slides where the overhang thickness is *c.* 15 m.

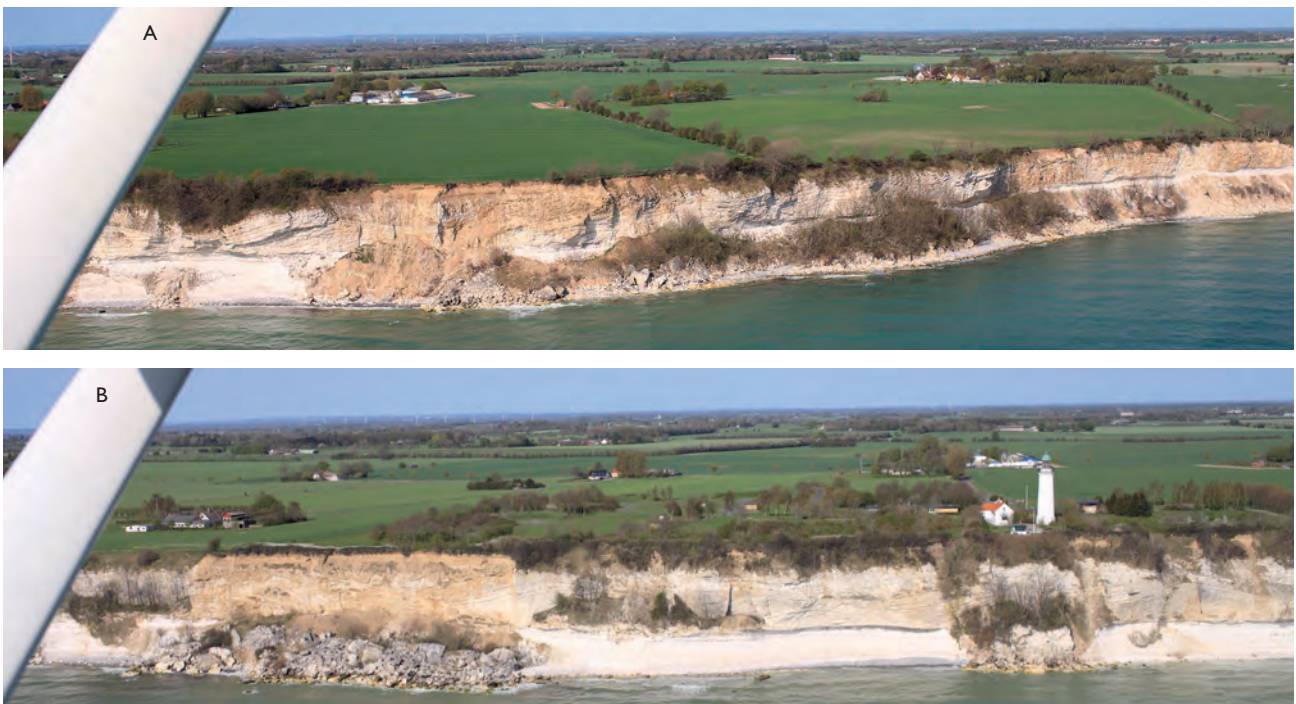
A significant cliff slide has occurred at Tømmestrup (Figs 1, 5A) and another one in the inner part of Harvig. At both

sites cliff-slide deposits will protect the cliff from erosion for the next decades.

Fig. 5. Cliff sections showing various types of rockfalls at Stevns Klint. A: Cliff slide at Tømmestrup. B: Cliff fall at the lighthouse of Stevns Fyr.

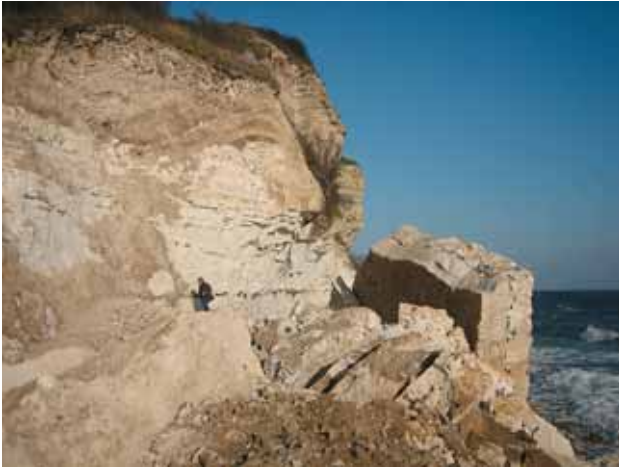
Fig. 6. The cliff collapse at Knøsen, which occurred in November 2011. The weight of fill deposited on top of the section added to the load of the overhang.

After our analysis, a rockfall of *c.* 300 m<sup>3</sup> occurred at Knøsen (Fig. 1). The rockfall was discovered on 6 November 2011. It was caused by the collapse of a 5 m overhang with a thickness of 2 m that constituted the floor of an old limestone quarry (Figs 3, 6). The floor carried the weight of removed overburden, in the form of clayey till and chert-rich limestone rubble. The collapse shows that an overhang with a thickness of just 2 m can become unstable even if the overhang is only 5 m. In other instances an overhang with a thickness of 15 m can be stable even with an undercut of more than 10 m.
